TWR-64216

Final Postflight Hardware Evaluation Report RSRM-28 (STS-53)

November 1993

This document is the final report for the Clearfield disassembly evaluation and a continuation of the KSC postflight assessment for the RSRM-28 (STS-53) RSRM flight set. All observed hardware conditions were documented on PFORs and are included in Appendices A through C. Appendices D and E contain the measurements and safety factor data for the nozzle and insulation components. This report, along with the KSC Ten-Day Postflight Hardware Evaluation Report (TWR-64215), represents a summary of the RSRM-28 hardware evaluation. The as-flown hardware configuration is documented in TWR-63638. Disassembly evaluation photograph numbers are logged in TWA-1989.

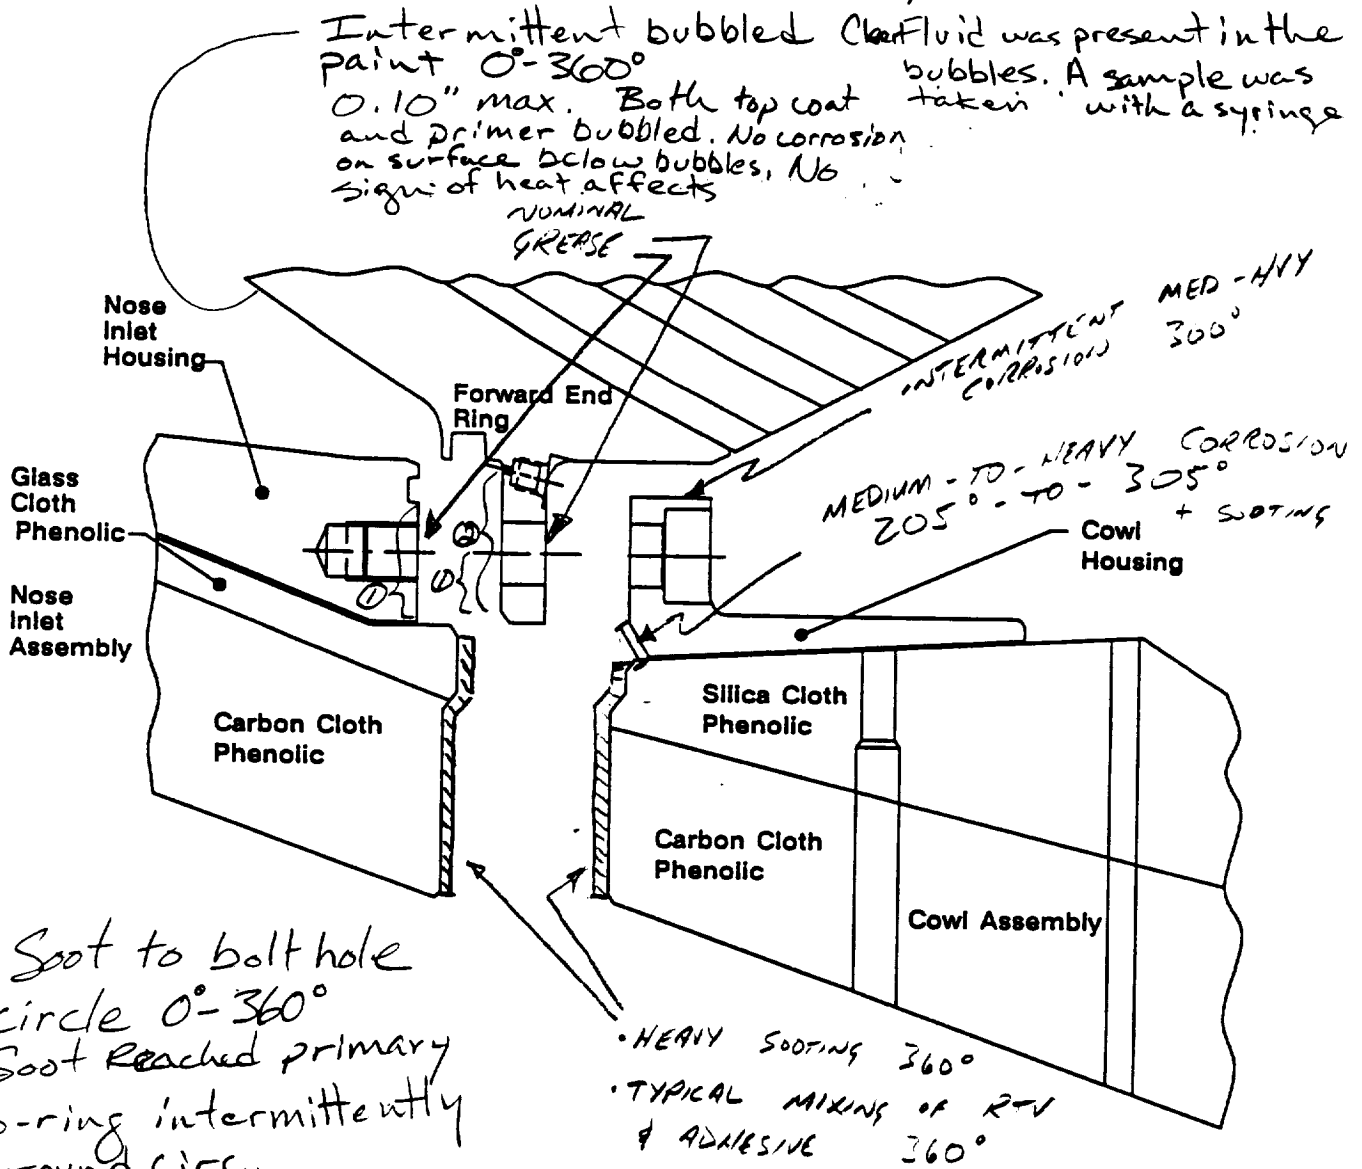
- 1) Soot to bolt hole circle 0°-360°
Soot Reached primary o-ring intermittently around circ.

- 2) Light corrosion 0°-360°

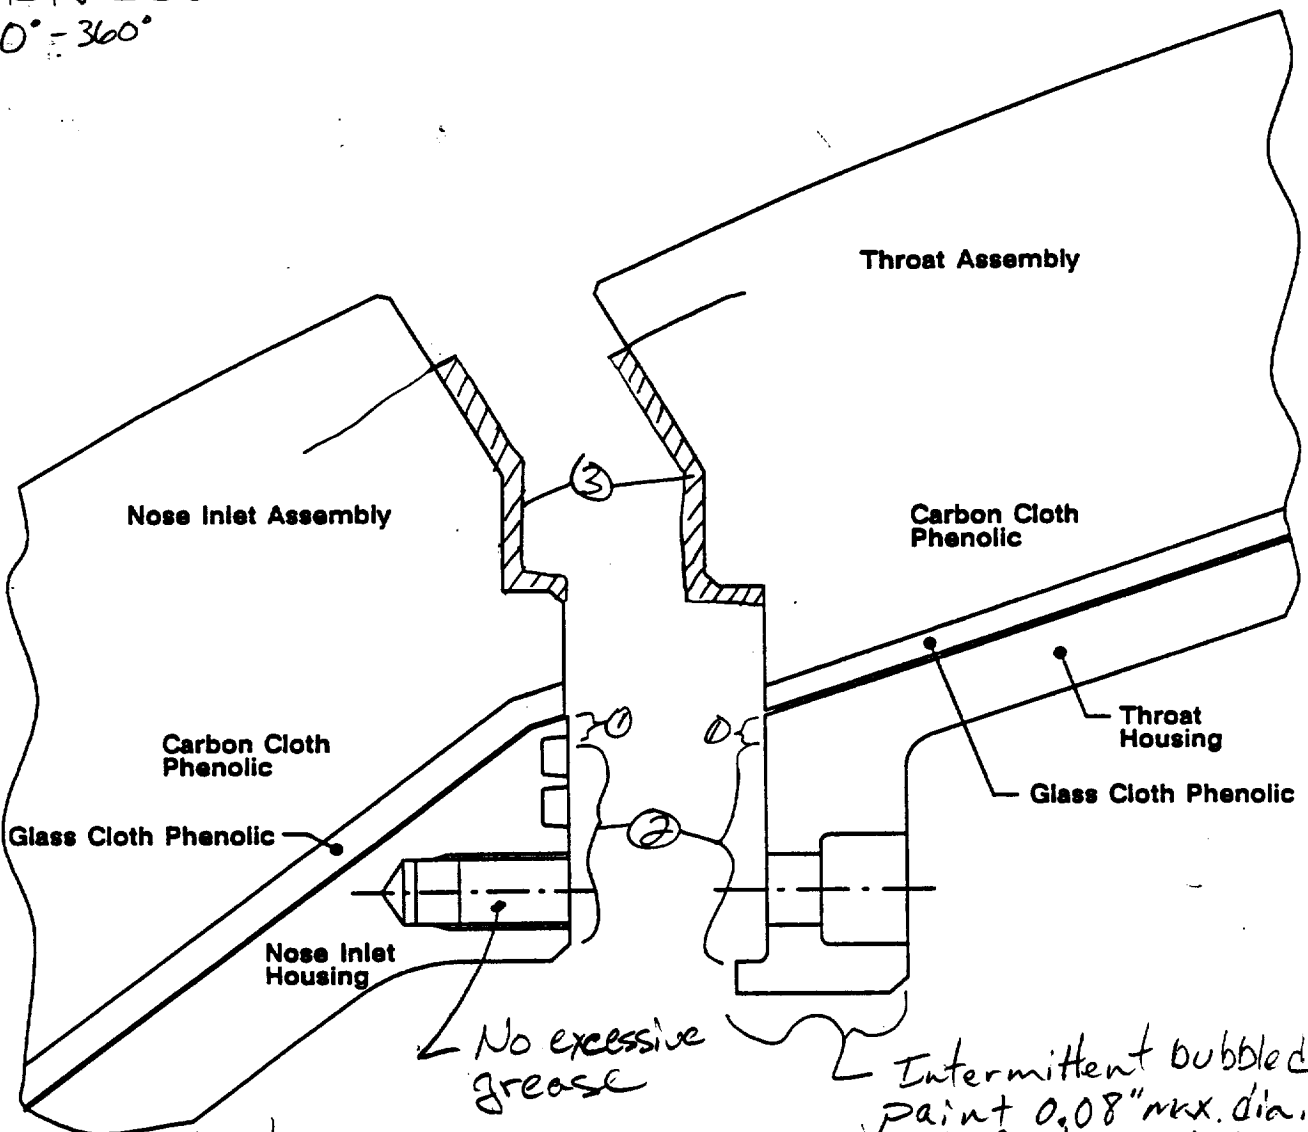
3) RTV below the char line
0° - 360°

1) Intermittent light-to-medium corrosion around the circ.

2) Nominal grease coverage with no corrosion.

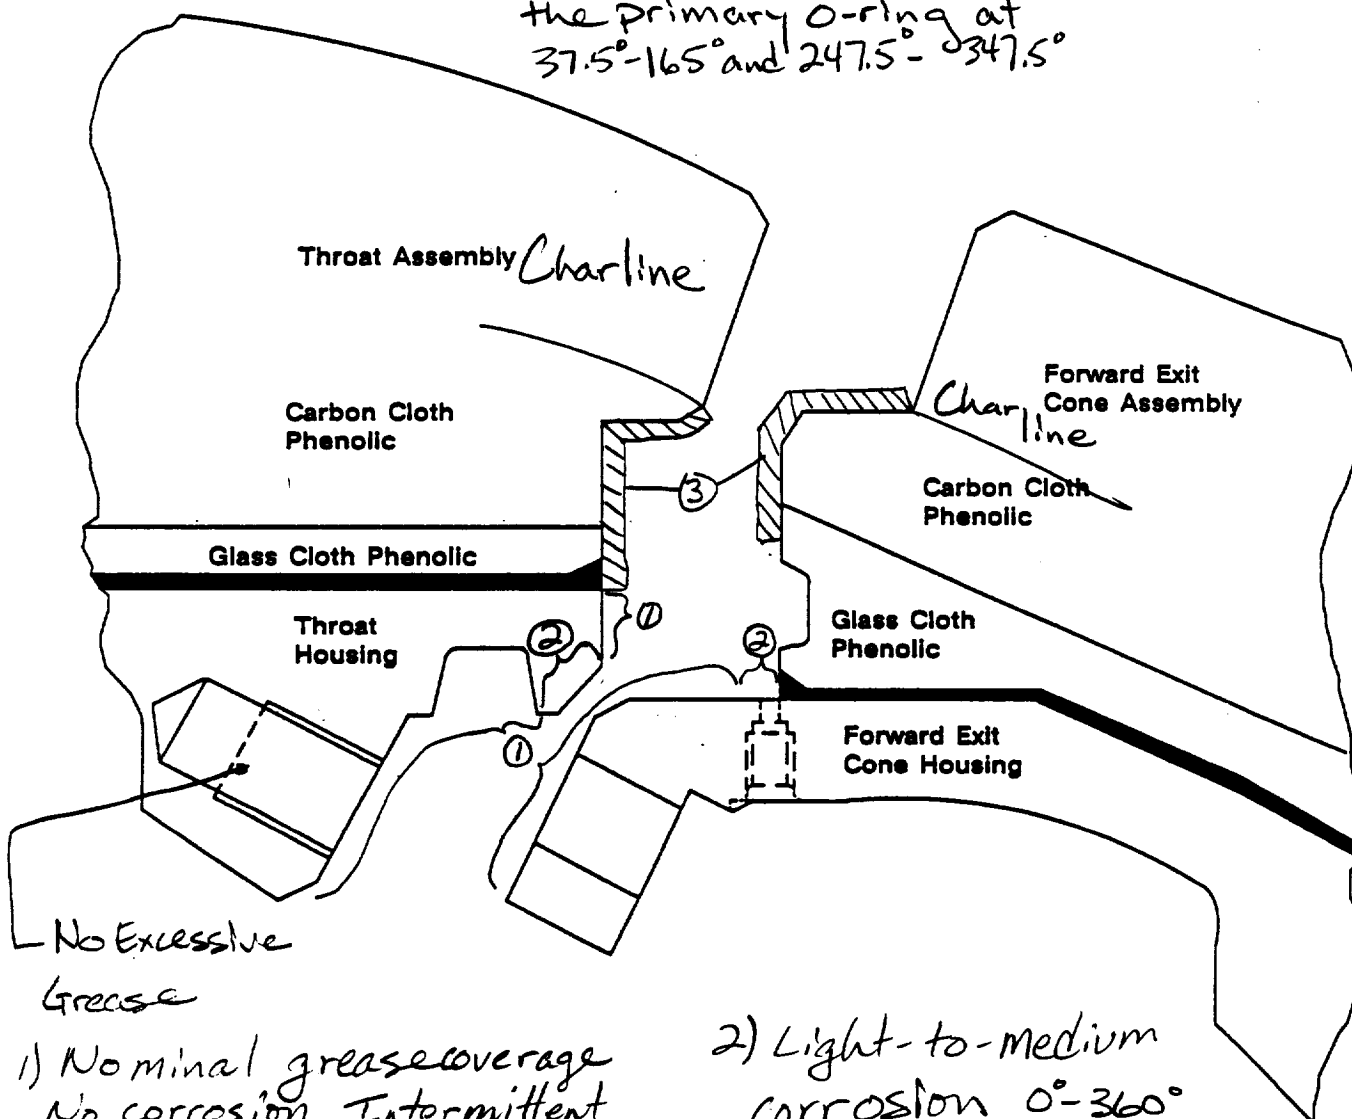
3) RTU reached below the Charline 0°-360°. Reached the primary O-ring at 37.5°-165° and 247.5°-347.5°

1) Nominal grease coverage
No corrosion. Intermittent drops of water.

2) Light-to-medium corrosion 0°-360° between the phenolics and secondary O-ring

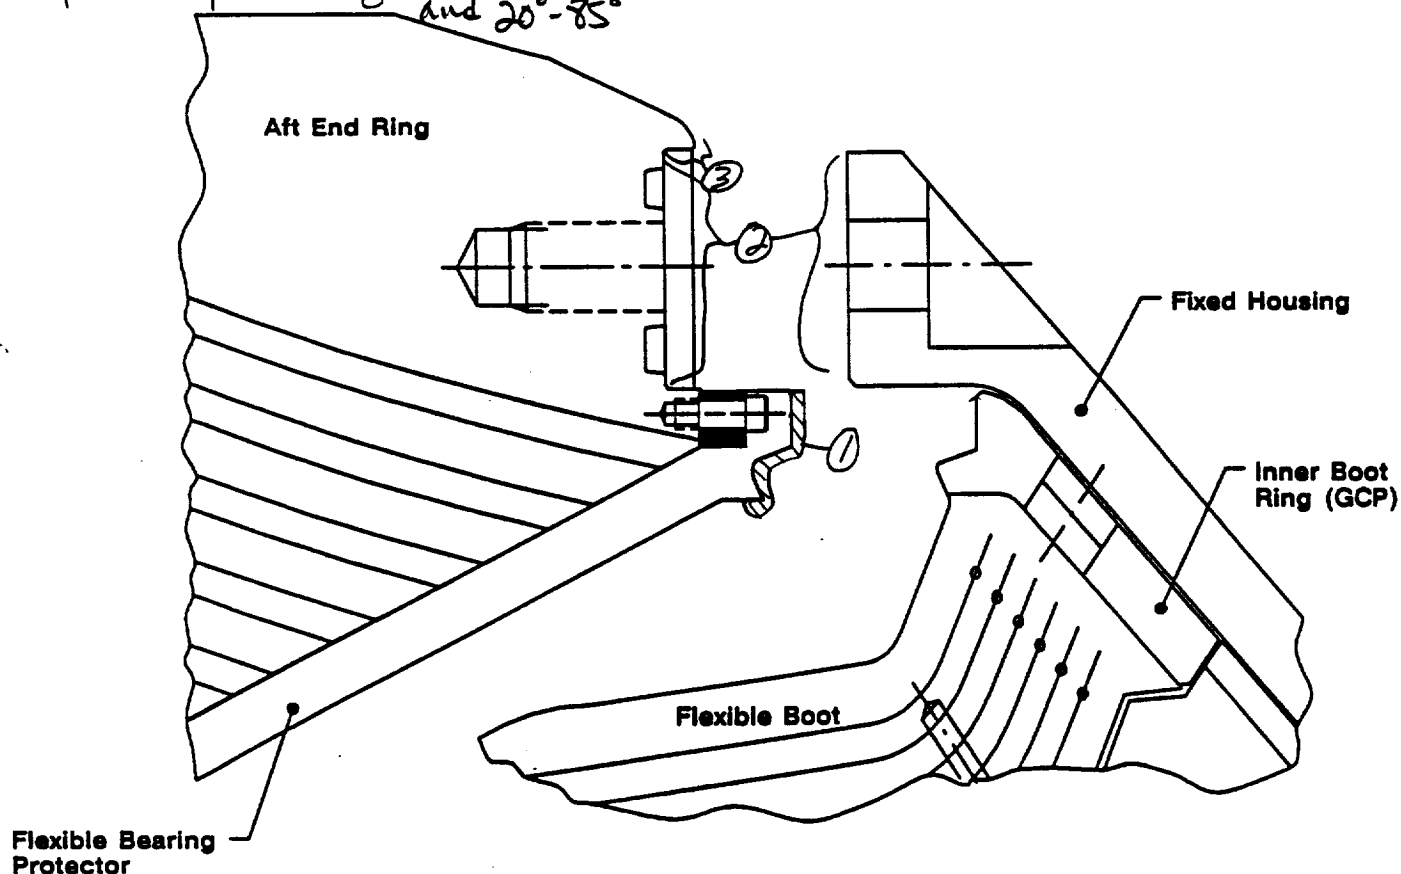
2) Nominal grease coverage with no corrosion

3) Intermittent medium corrosion 0°-360°

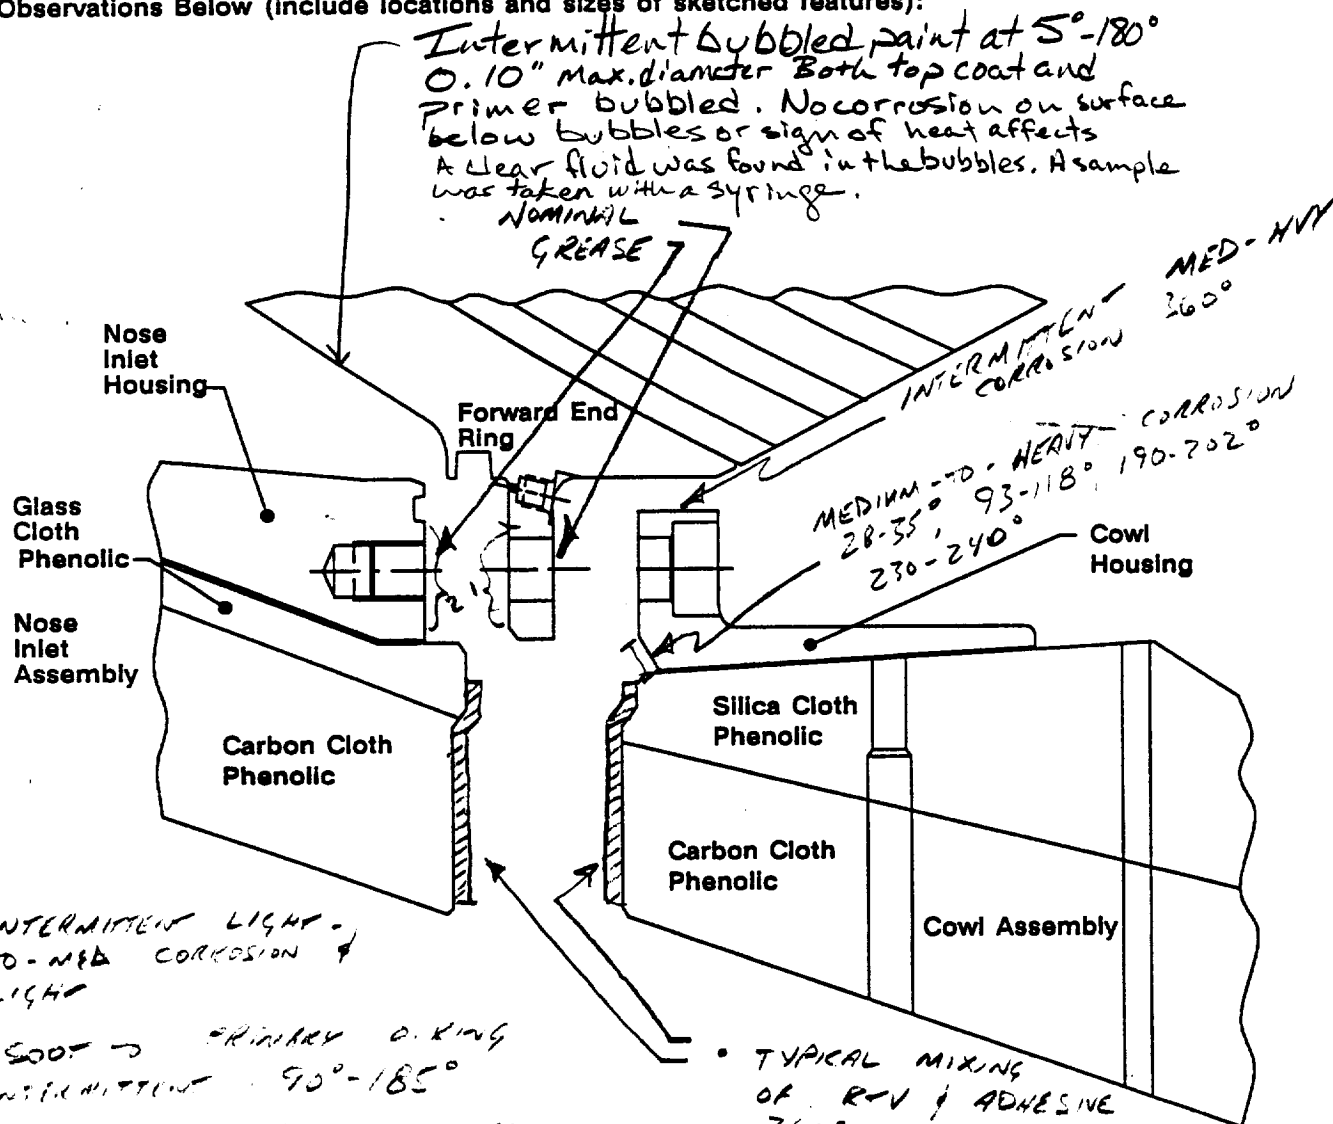
- 1) INTERMITTENT LIGHT-TO-MED CORROSION & LIGHT
- 2) SOOT - PRIMARY D.R. KING INTERMITTENT 90°-185°
- INTERMITTENT LIGHT-TO-MEDIUM CORROSION 360°

- TYPICAL MIXING OF R-V & ADHESIVE 360°
- HEAVY SOOTING 45°-210°
- LIGHT-TO-MEDIUM SOOTING 210°-0°-45°

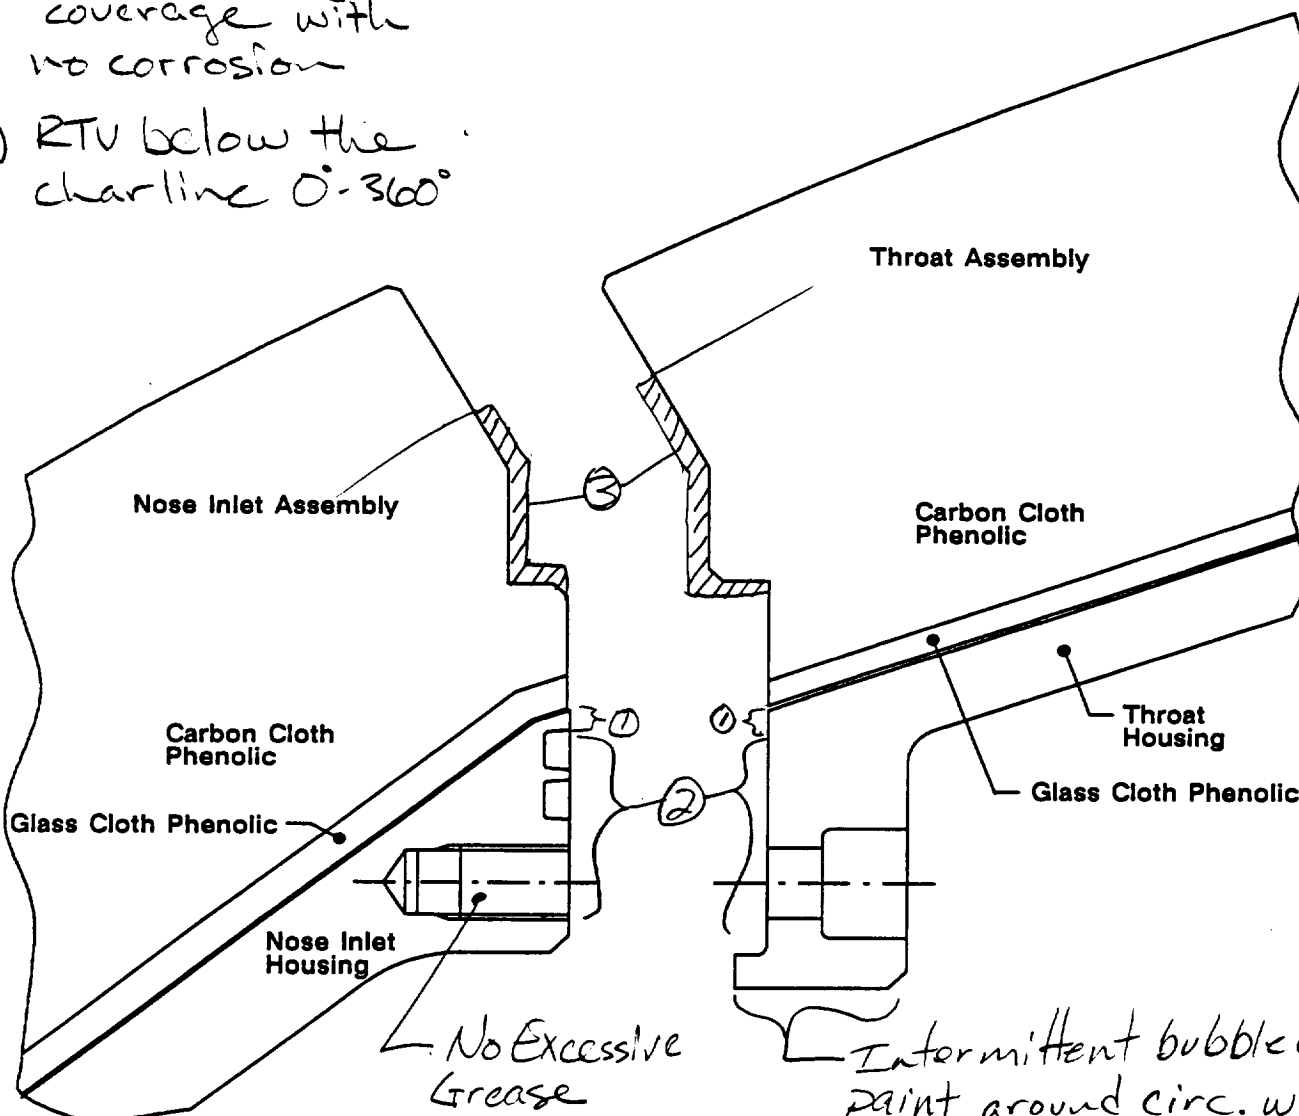
3) RTV below the charline 0°-360°

Intermittent
1) Light-to-medium corrosion around the circ.

Intermittent bubbled paint around circ. with a max. dia. of 0.05"
No Fluid in bubbles, corrosion or sign of heat affects observed.
